No. 1573

FLIGHT MEASUREMENTS OF THE FLYING QUALITIES OF
FIVE LIGHT AIRPLANES

By Paul A. Hunter

Langley Memorial Aeronautical Laboratory
Langley Field, Va.

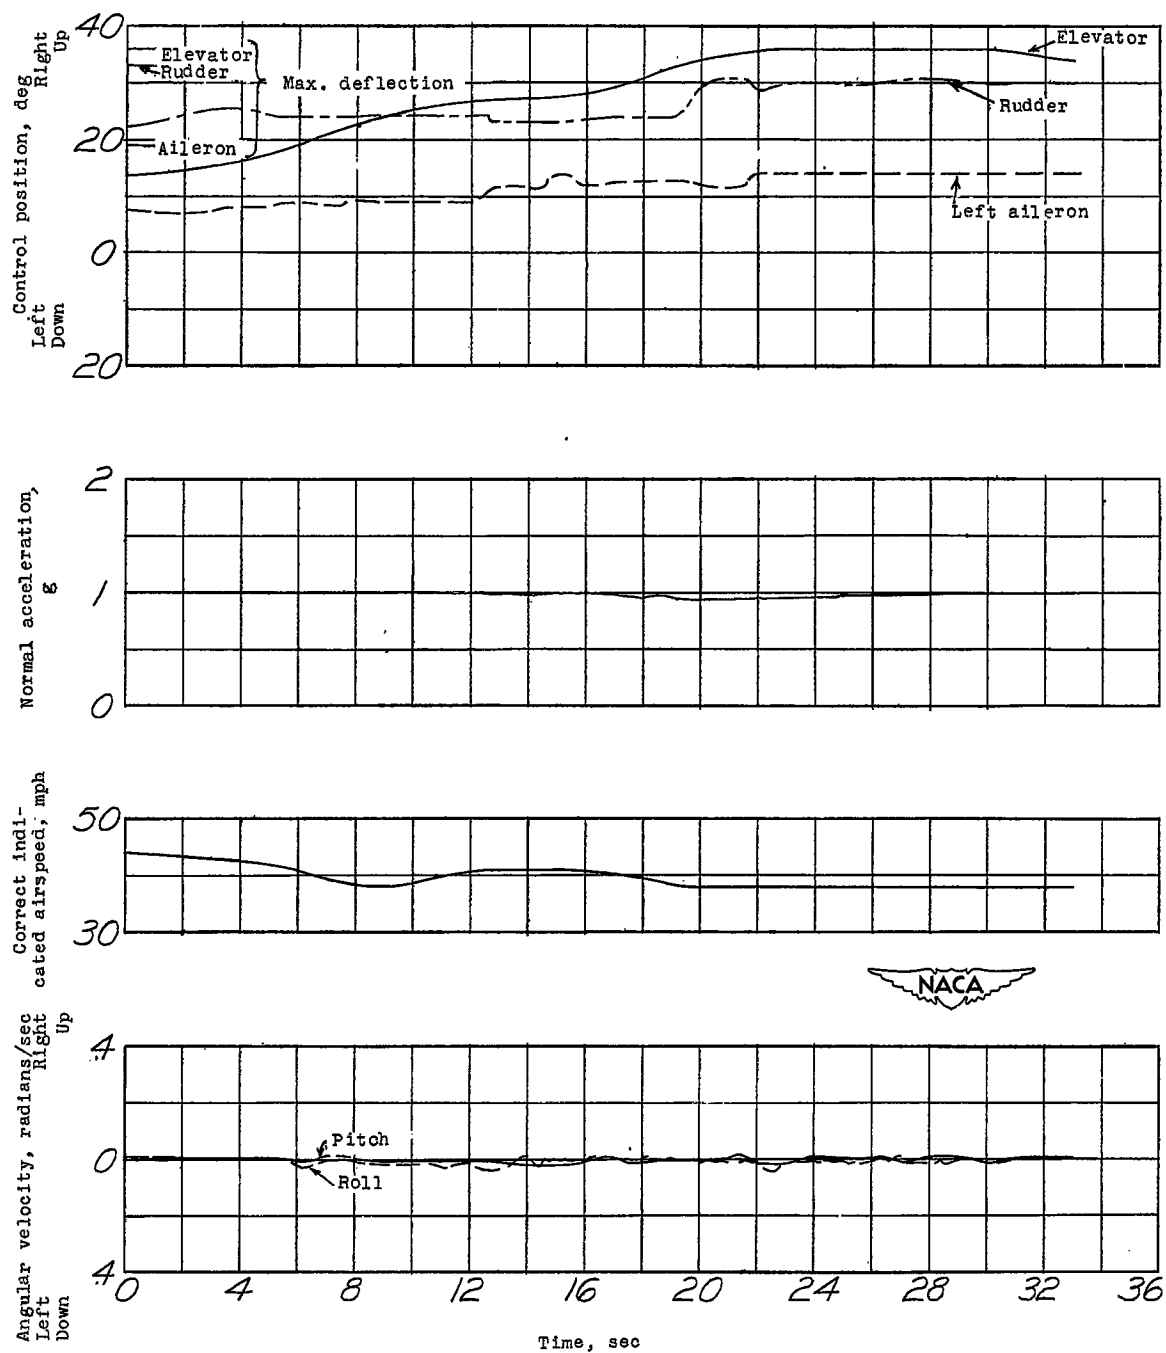
Figure 43.- Attempt to stall from power-off left sideslip. Note that full-up elevator does not produce lateral instability. Airplane 3.

In stalls carrying initial sideslip the relation between the up-elevator angle and the angle of attack for lateral instability changed from that which existed for straight unyawed flight so that greater amounts of up-elevator angle or more rearward positions of the stick were required to stall in every case. In the power-on conditions, the change in pitching moment produced by sideslip was not sufficient to prevent the complete stall. In these stalls the instability was increased in violence because the control disposition required for the sideslip carried corresponded to that used in spinning. The sequence of events when instability developed was a dropping of the downwind wing and a rapid turning toward the dropping wing because of the increased drag of that side as well as the sudden loss of equilibrium between the angle of bank and the cross-wind force. In every case the roll occurred in the direction opposite to the sideslip. These characteristics are shown in figures 41 and 42. In power-off conditions, sideslip angles of 20° so limited the effectiveness of the elevator that complete stalls could not be produced with the stick full back, as shown in figure 43; although with 10° sideslip, rolling instability could be produced.

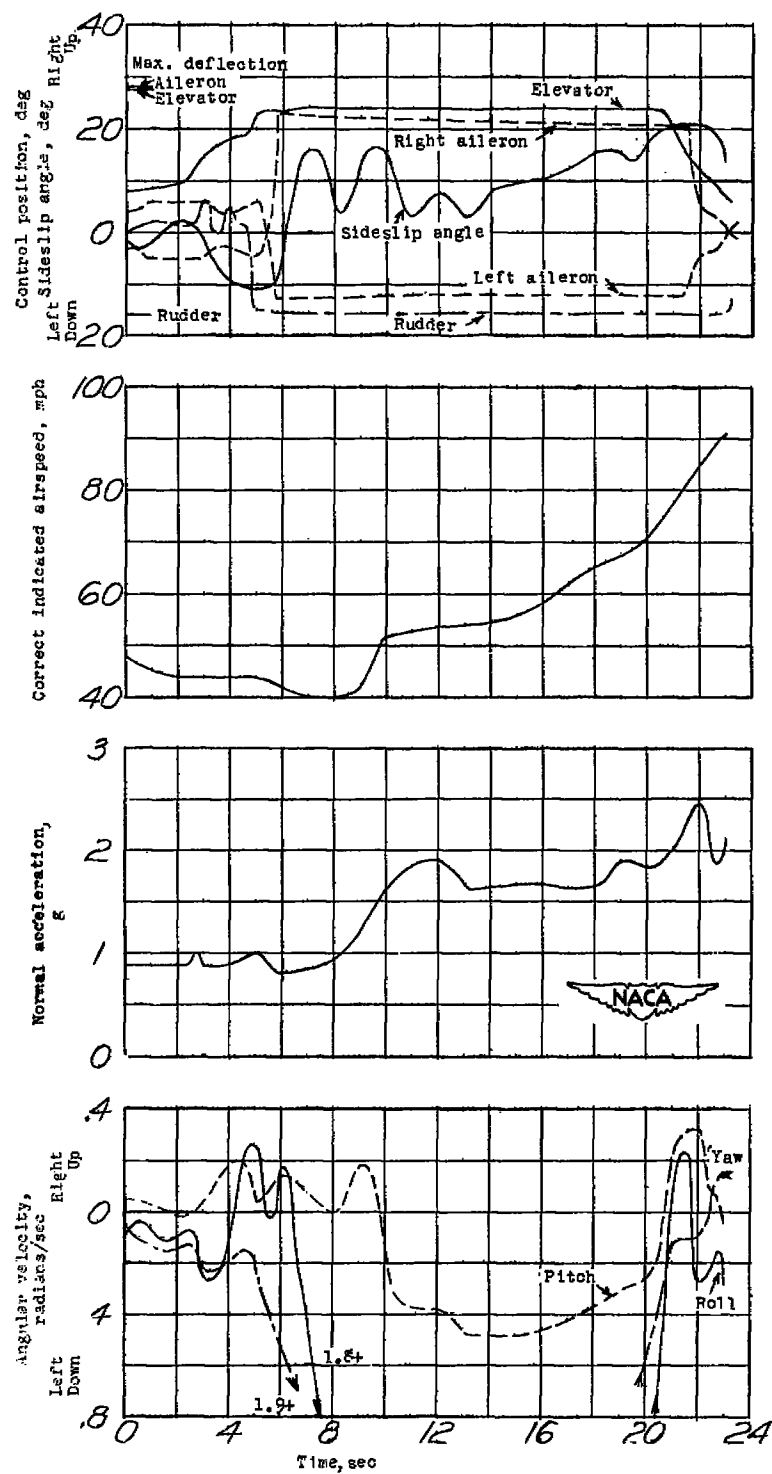
Figure 44.- Time history of entry and recovery from a spin. Flaps up; power on; airplane 4.

Recovery was rapid and automatic when the power was reduced or the controls were neutralized. A typical time history of a spin and recovery is shown in figure 44. All attempts to spin from other conditions resulted in spirals.

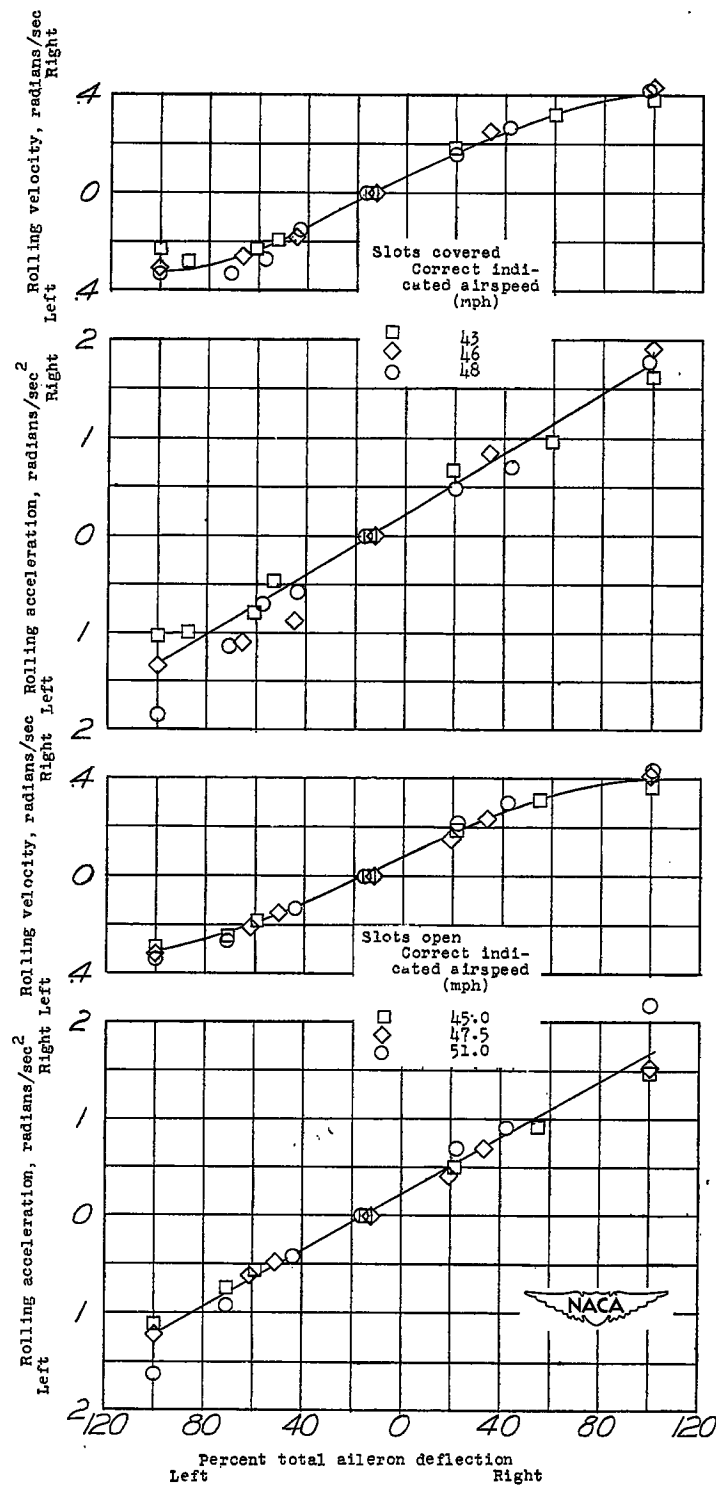
Figure 45.- Effect of slots on aileron characteristics. Airplane 4.

The characteristics specifically investigated were stalling, aileron effectiveness at speeds close to the stall, and longitudinal stability. Figure 45 presents comparable aileron-effectiveness data for both slotted and unslotted conditions. It will be noted that the slots had no measurable effect. Data on the longitudinal stability also showed an inconsequential effect. Although actual records are too lengthy to include, no measurable effect of the slots on stalling characteristics was discernible either to the pilot or through analysis of the data. The spinning data also remained unchanged.
